TITLE OF THESIS: An Investigation and Analysis
of a Landslide Near Raush Valley,
British Columbia.

AN INVESTIGATION AND ANALYSIS OF A
LANDSLIDE NEAR RAUSH VALLEY, BRITISH COLUMBIA

The CN Rail North Division line is plagued by many areas of slope instability on its passage through the Fraser River valley in central British Columbia. The surficial geology of the river valley is dominated by recent glacial lake clays of medium to high plasticity with discontinuous silt laminations. The presence of numerous alluvial fans and aprons submerged beneath the glaciolacustrine deposits results in widely fluctuating groundwater levels and, in some cases, artesian conditions.

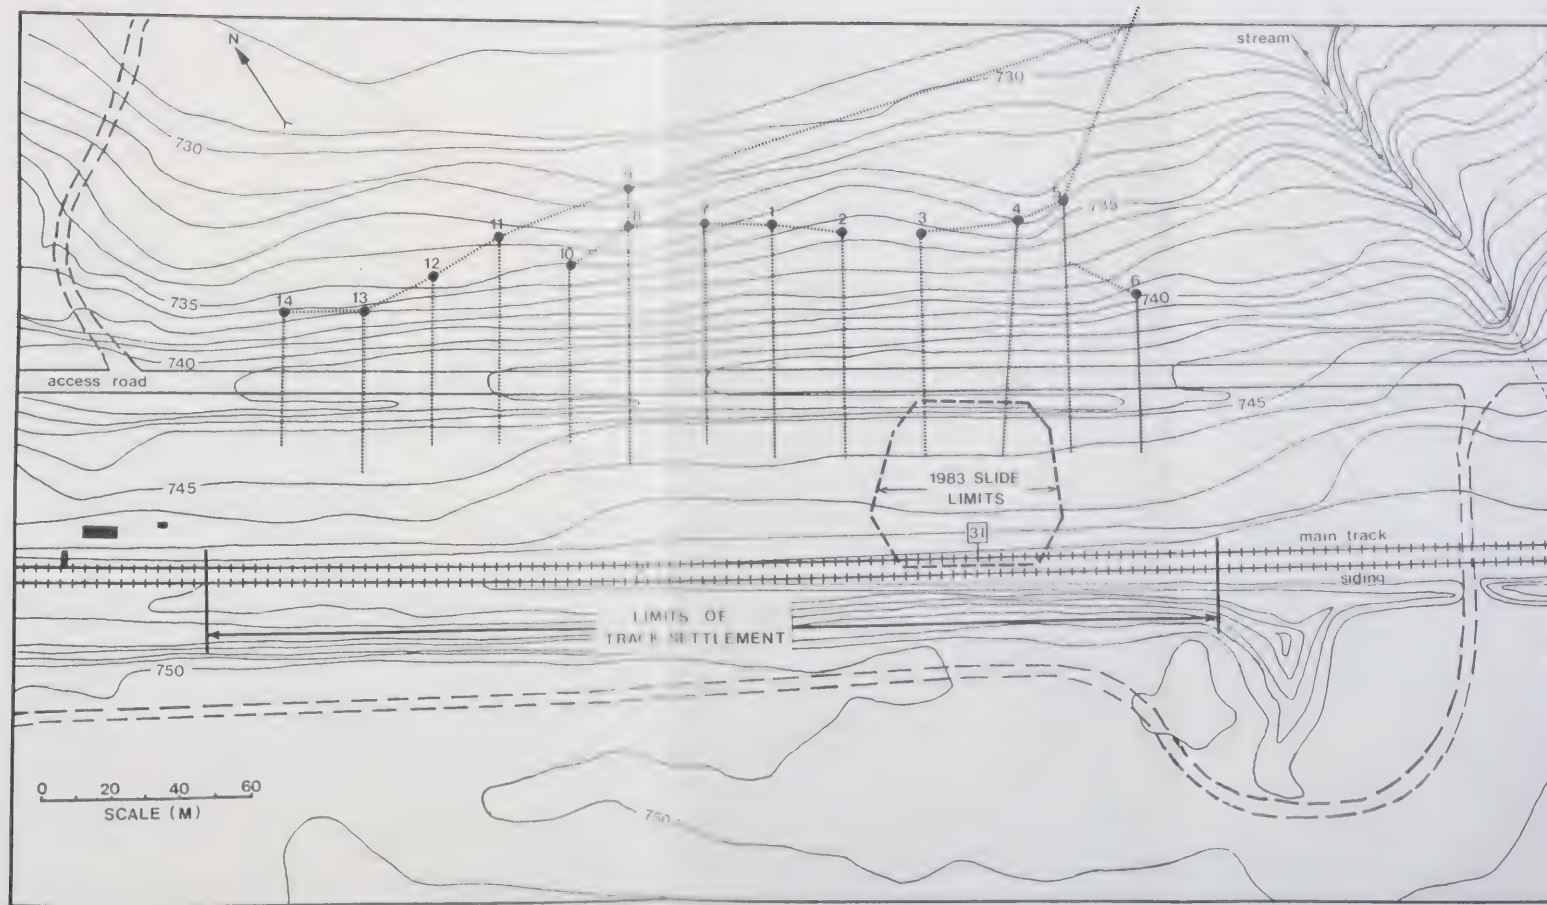
Figure 2. Site plan view illustrating the limits of the slope movements and the location of the counterfort drains.

The slide measured approximately 100 metres in width and 50 metres in length and was confined to a shallow depth. A visible headscarp was evident as well as several radial tension cracks and a well developed toe bulge. Small springs of water were seen ponding in the drainage ditch beside the toe bulge. A settlement of approximately 200 mm occurred in the track at the crest of the slope. Figure 14 illustrates the slide geometry in profile. A slight offset is visible in the line of telephone poles that traverses the site.

A satisfactory solution to the instability problem was developed as a combination of drainage methods incorporating counterfort drains and a stabilizing berm. The stabilizing berm was constructed midslope to arrest slope movements initiated at the crest. The counterfort drainage system was installed beneath the stabilizing berm. It consists of thirteen trenches running downslope. The trench drains effectively control the pore pressures in the soil beneath the stabilizing berm and prevent failure of the slope under the berm weight.

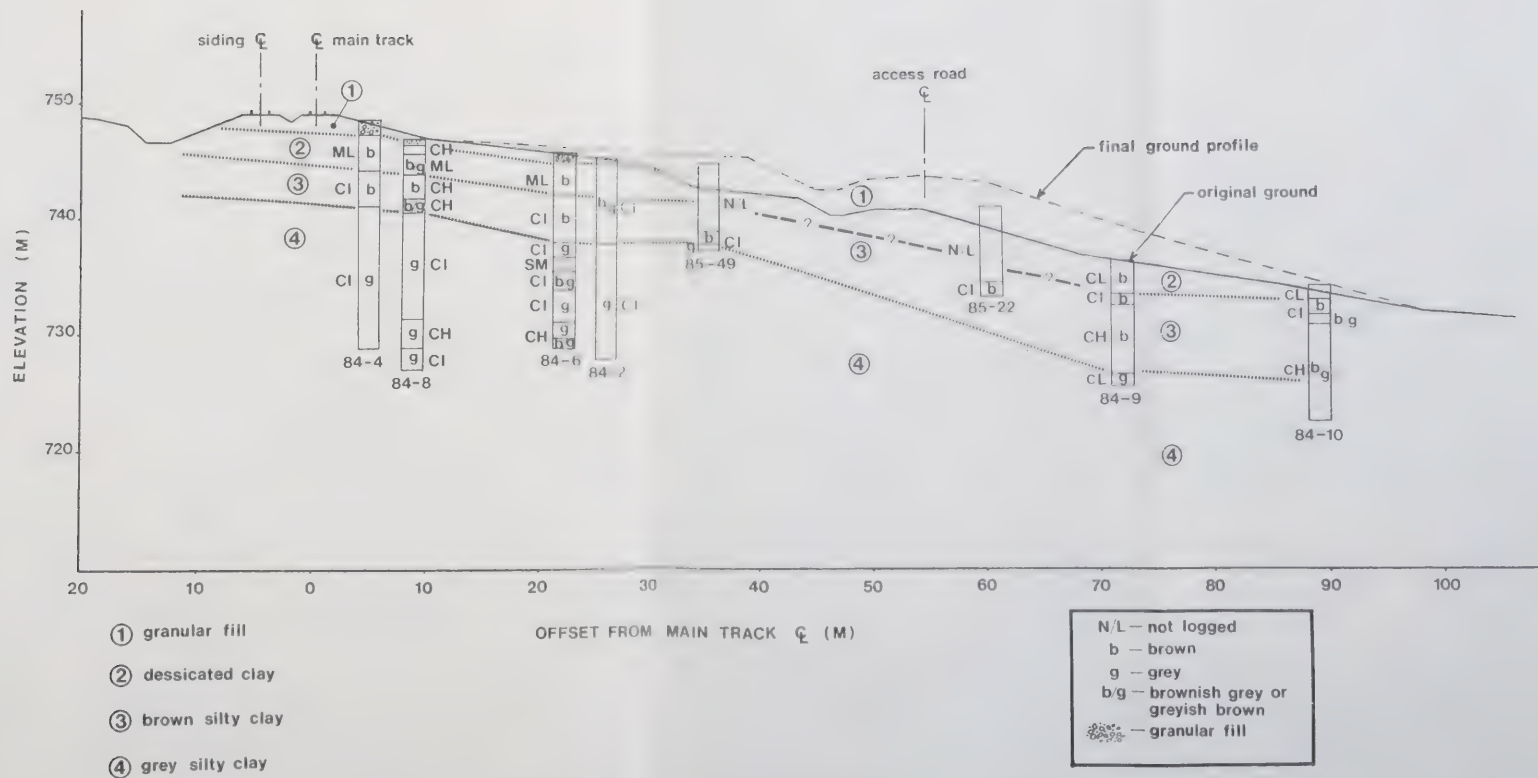
Figure 8. Geologic cross-section developed from borehole data.

A typical geologic cross-section developed from borehole data obtained during the 1984 and 1985 drilling programs is presented in Figure 8. The surficial unit consists of 1-2 metres of dessicated, dry, silty clay containing many organic rootlets. Underlying the dessicated cap is 4-5 metres of brown medium to high plasticity silty clay that is uniform, moist, and contains discontinuous silt lenses. The silt lenses vary in thickness from 1 mm to 3 cm and have a silvery colour indicating their high mica content. No continuity of lensing was found from borehole to borehole on a 20 metre grid spacing.

The interface between the two clay units lies approximately parallel to the original ground surface. When this information is coupled with the noted inclination of the silt lenses, it appears that these sediments were deposited on the sloping margins of a glacial lake, with bedding dipping towards the centre of the valley.

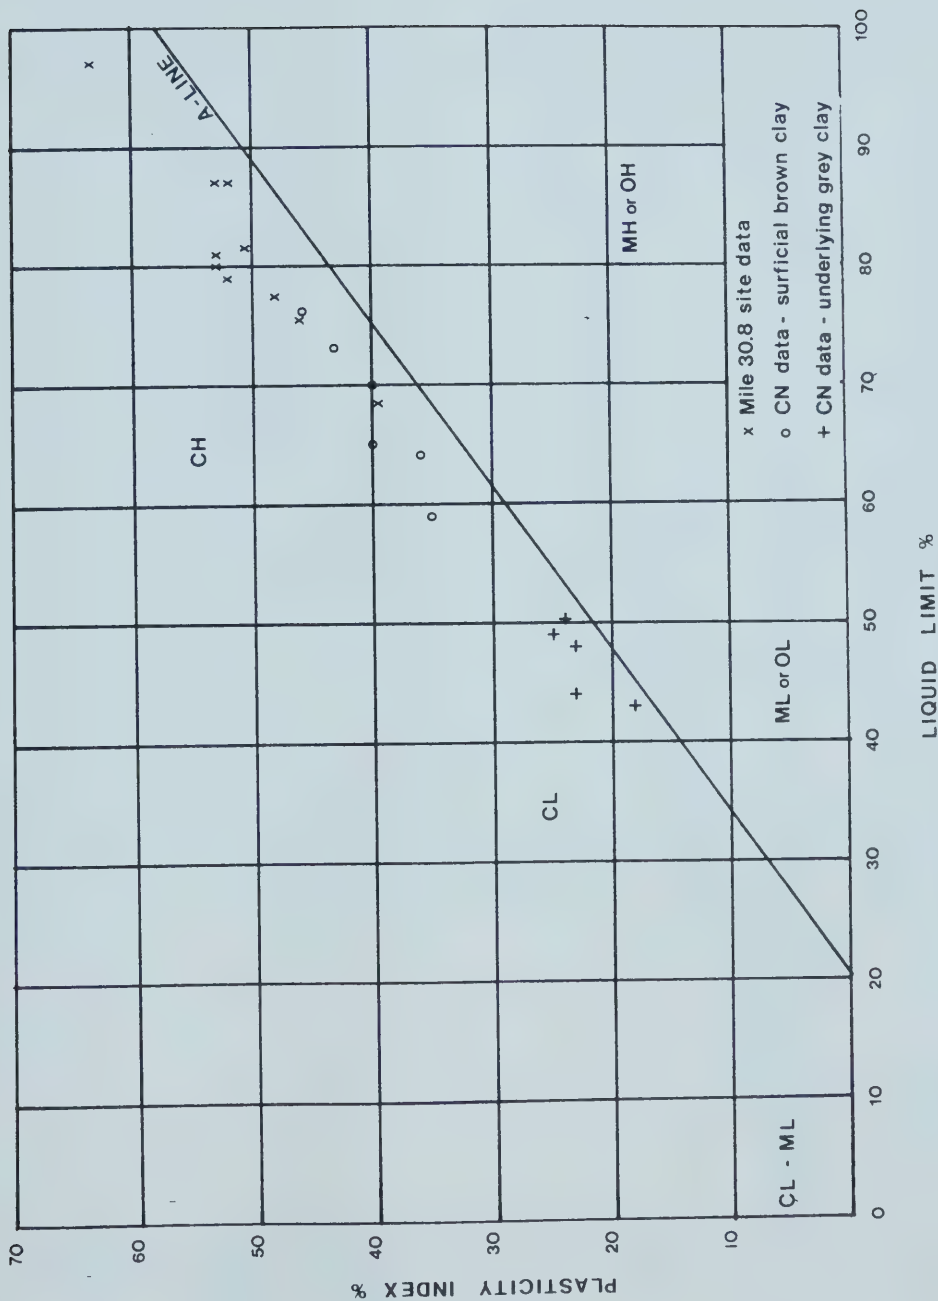
Figure 9. Plasticity chart for lacustrine deposits at the CN Rail Mile 30.8 site and the surrounding area.

Atterberg Limit tests were performed to yield a continuous profile in one borehole. Figure 9 illustrates the data obtained from the Mile 30.8 site plotted against CN data obtained at other sites in the Fraser Valley. The plasticity chart classes all samples as high plasticity inorganic clay. Although some CN data at nearby sites indicates the presence of a high plasticity unit overlying a medium plasticity grey-brown silty clay, no contrast was noted in the soil plasticity at the Mile 30.8 site.

From the index testing data there is no clear indication of a contrast between the upper and lower clay units on the basis of undrained strength, moisture content or plasticity. These units are likely very similar in composition and stress history, and for practical purposes can be considered one unit. On the basis of the index and classification testing the lacustrine clay would be described as a medium to stiff, high plasticity silty clay. The Unified Soil Classification is CH.

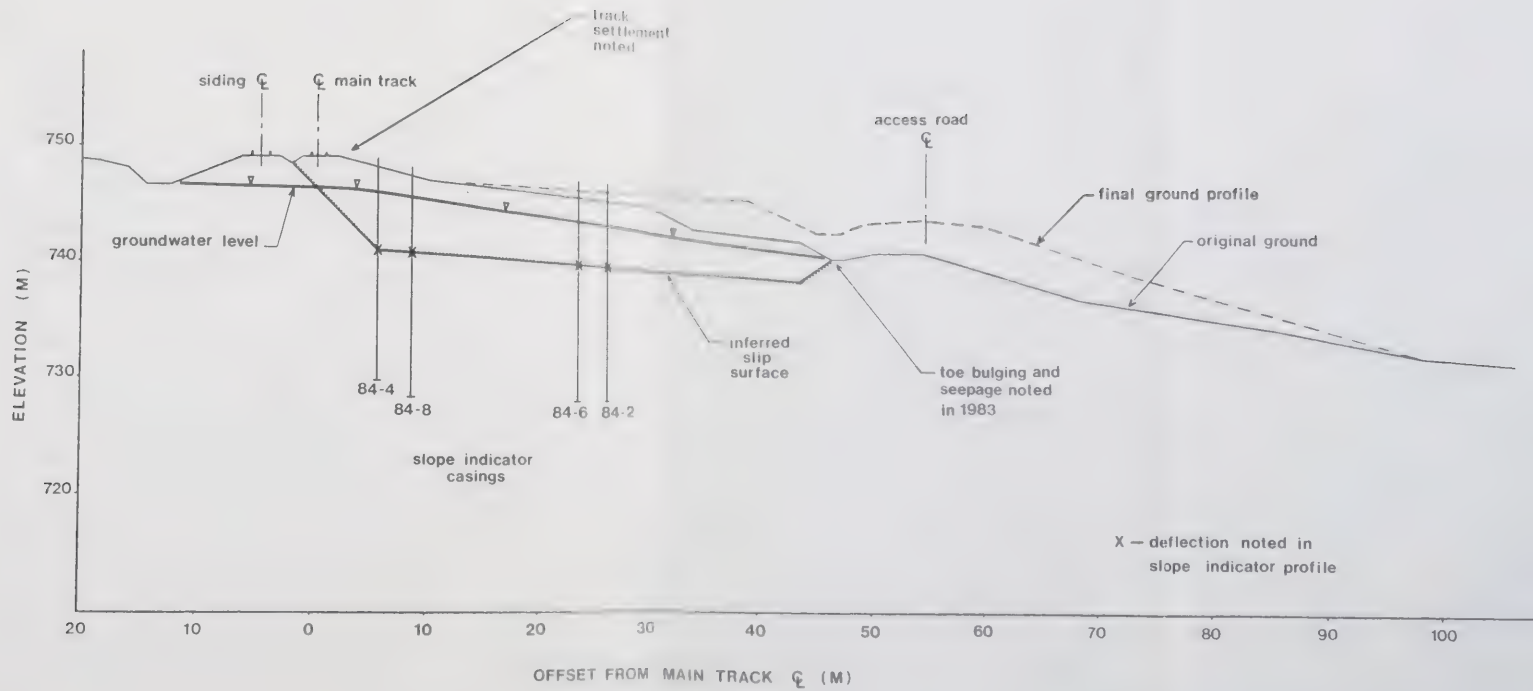
Figure 14. Slope profile illustrating the 1983 slide geometry as inferred from site observations and slope indicator profile records.

Figure 14 illustrates the simplified slope geometry complete with the phreatic surface located by site observations of standing water pools. The critical slip surface is developed from information gained from slope indicator profiles, observations of toe bulging, and the observed settlements of the railroad tracks.

period of 70 years since original line construction have reduced the available soil strengths to near-residual values. This weakening of the soil combined with seasonally high groundwater levels is considered to be the cause of the failure of the slope.

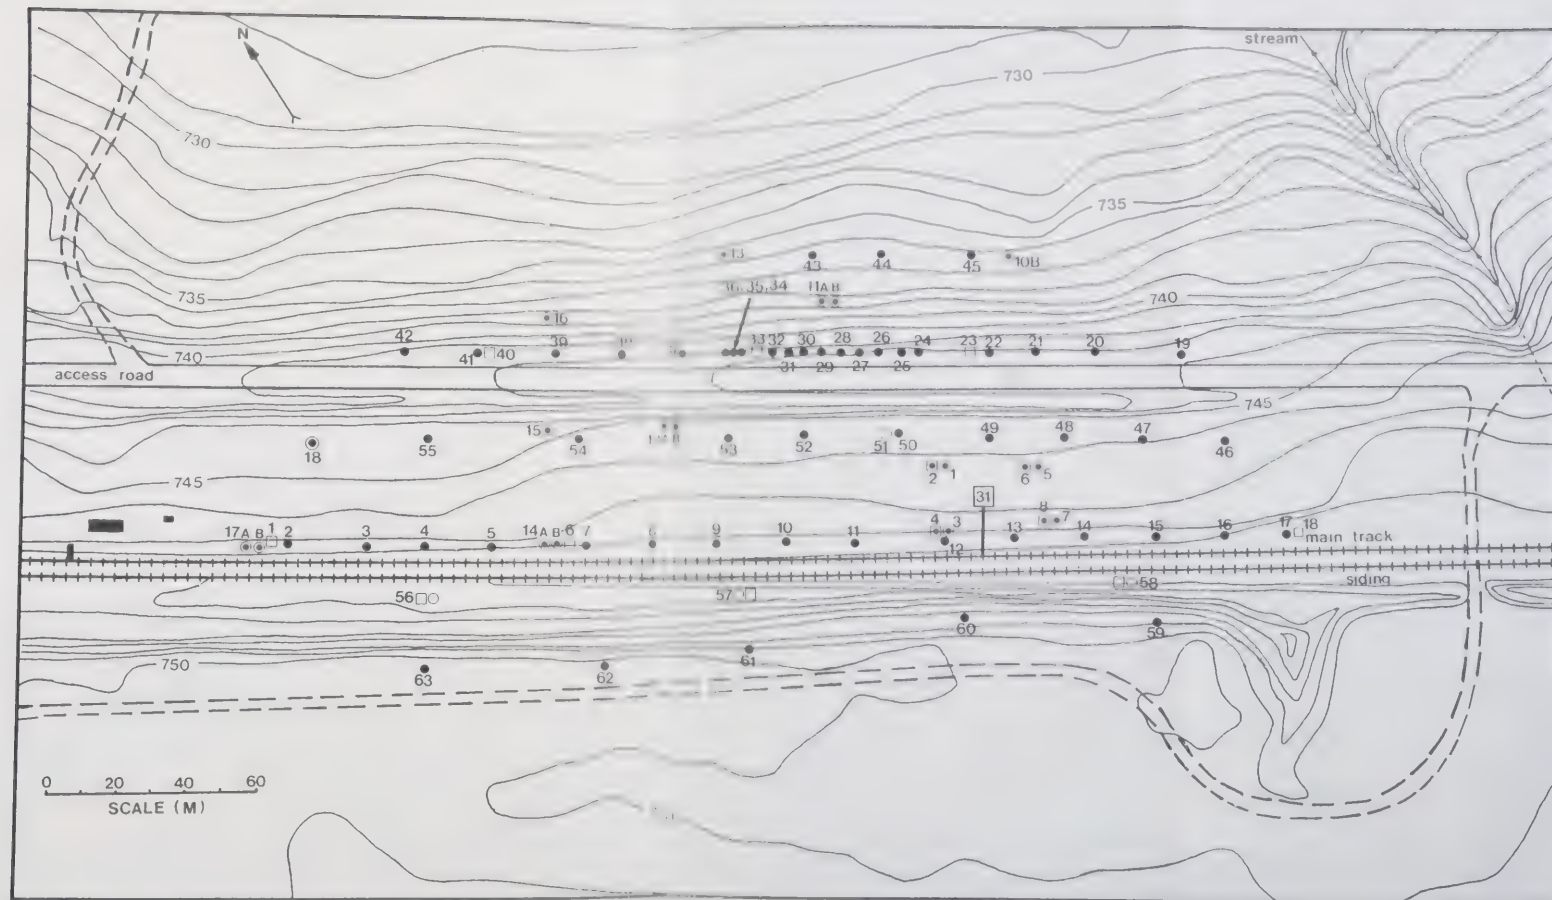
Figure 15. Instrumentation location plan.

6) The standpipes installed in sand-filled boreholes on the upslope shoulder of the track ballast (units SP85-56, SP85-57, and SP85-58 in Figure 15) generally indicate water levels consistent with observed levels in the drainage ditch. The Casagrande-type piezometers, however, indicate water levels considerably below those indicated by surrounding pneumatic piezometers. These sealed Casagrande-type tips are generally installed at greater depth than the pneumatic piezometer tips. The discrepancy in phreatic levels could result from the presence of a downward flow gradient, perched water table conditions, or from some irregularity in the groundwater conditions caused by unusual stratigraphic features.

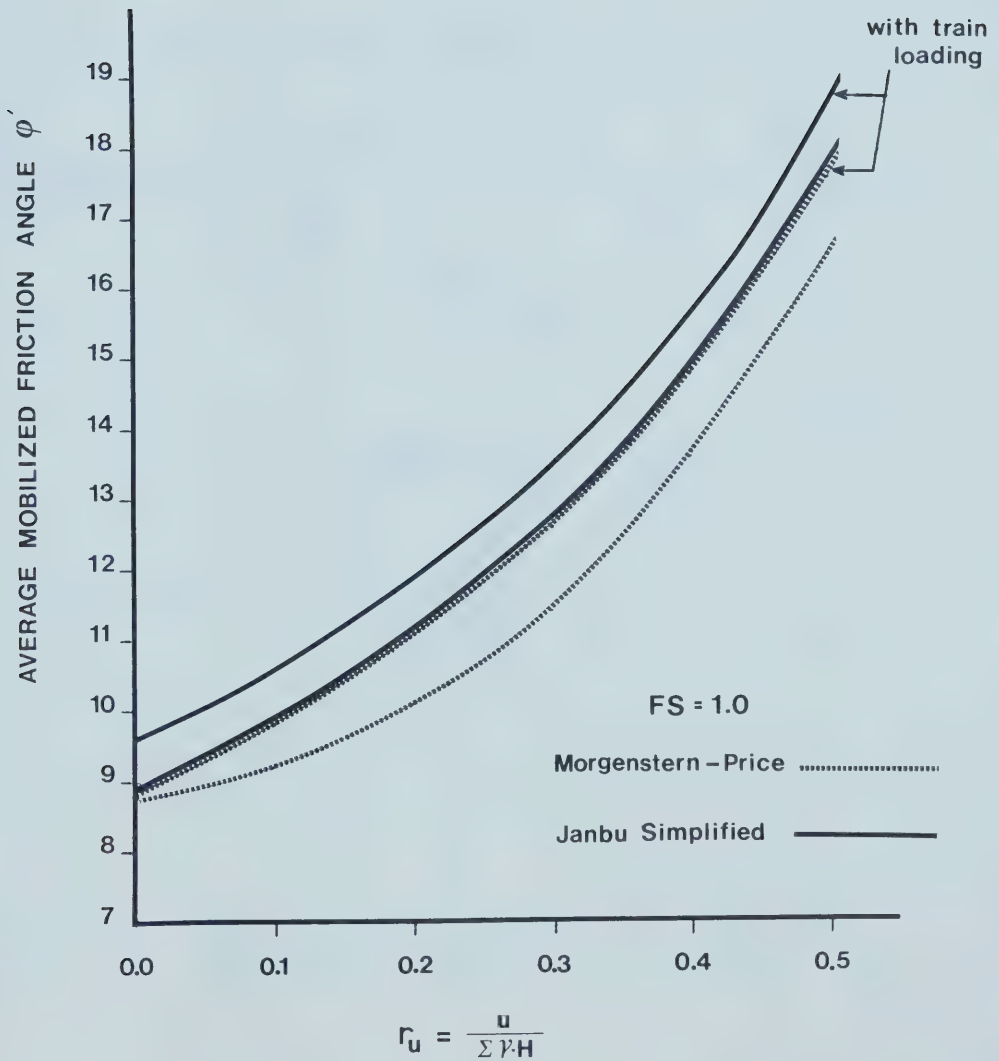
Figure 16. Parametric back-analysis of 1983 Slide using Morgenstern-Price and Janbu Simplified analyses.

Parametric analyses were performed for varying phreatic surface conditions using the Morgenstern-Price analysis. Porewater pressure ratios, r_u varying from 0.0 (dry slope) to 0.5 (phreatic surface co-incident with ground surface) were input to produce the relationship between

A probable range of r_u values, representative of groundwater conditions present at the time of the slide, of 0.2 to 0.4 produces a range of average mobilized friction angles between $\phi' = 10^\circ$ and 15° at the time of sliding.

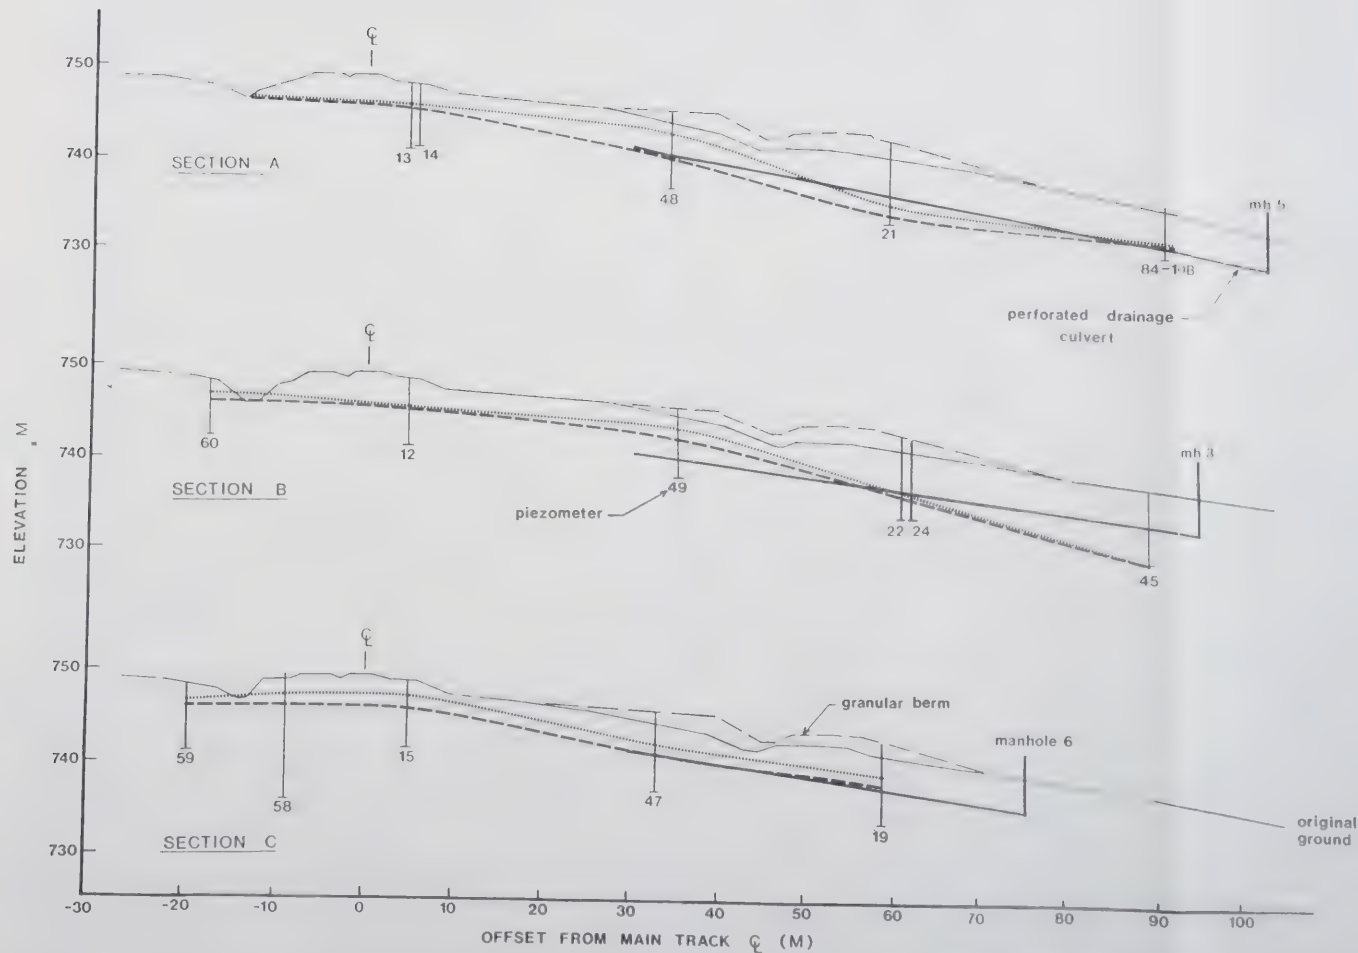
Figure 22. Slope cross-sections taken along the dip of the slope illustrating the piezometric levels present before and after drain and berm construction.

Figure 22 illustrates the sections taken parallel to the dip of the slope. These show the position of the

4) The phreatic profile is generally parallel to the ground surface except where influenced by the counterfort drains (Figure 22).

5) Phreatic levels indicate the presence of standing water in the drainage ditches on the upslope shoulder of the access roadway, at some locations (Figure 22). This is consistent with site observations.

Observations by Weeks (1969) and Symons and Booth (1971) on groundwater response to a counterfort drainage system installed in a stiff fissured clay deposit indicate that the influence of the drains is not fully developed until some distance (3.5 times the drain spacing in the reported case) downslope from the drain heads. They also reported that the drain's influence on groundwater conditions quickly reduced to zero at a short distance (0.3 times drain spacing) downslope of the drain ends. At the Mile 30.8 site full drawdown occurs at approximately 25 metres (1.25 times drain spacing) downslope of the drain heads (Figure 22). No instrumentation was installed downslope of the the drain ends.

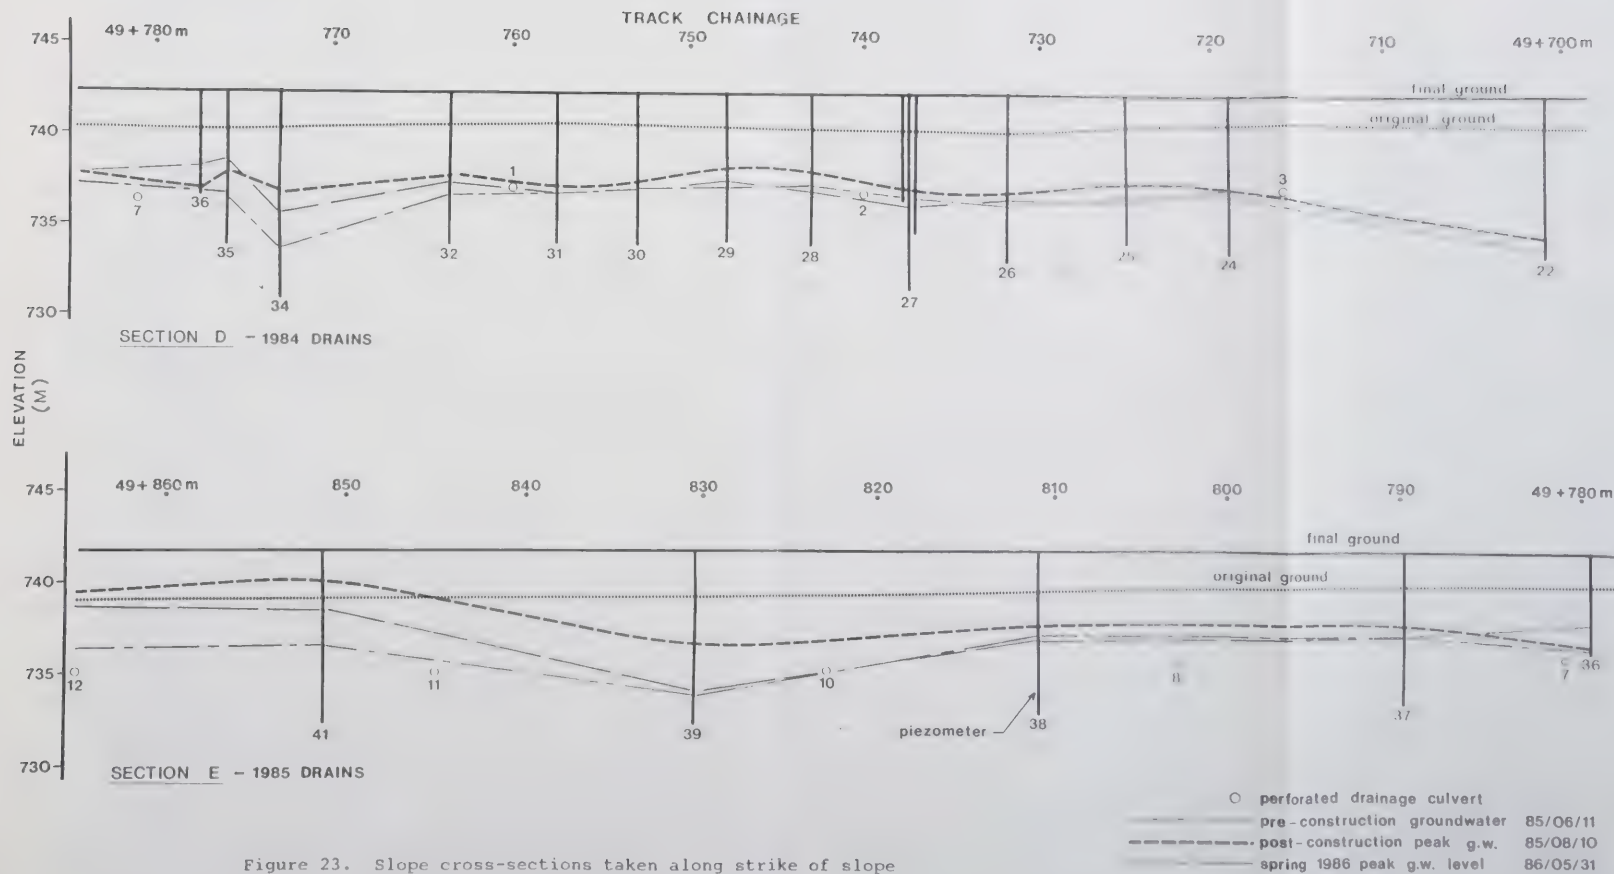
Figure 23. Slope cross-sections taken along strike of slope illustrating drawdown influence of both the 1984 and the 1985 counterfort drains.

7) The drawdown profile between successive drains is relatively flat, as illustrated in Figure 23. The phreatic level is generally closer to the level of the drain inverts in the section stabilized by 1984 drains than in the section stabilized by 1985 drains. This again suggests that there is a time lag between drain installation and full effectiveness. The flat drawdown profile between drains suggests a relatively high horizontal to vertical permeability ratio.

8) The rise in the level of the phreatic surface due to berm construction is substantially greater in the area stabilized by 1985 drains compared to the area of 1984 drains (Figure 23). An average of 2 metres of fill was placed on the roadway to act as a stabilizing toe berm for the upper slope. This resulted in an average increase in the phreatic level of 0.6 metres and 1.7 metres for the 1984 drain area and the 1985 drain area respectively (or $\bar{B}$ values of approximately 0.16 and 0.39 respectively). This again indicated that the 1984 drains were functioning more efficiently.

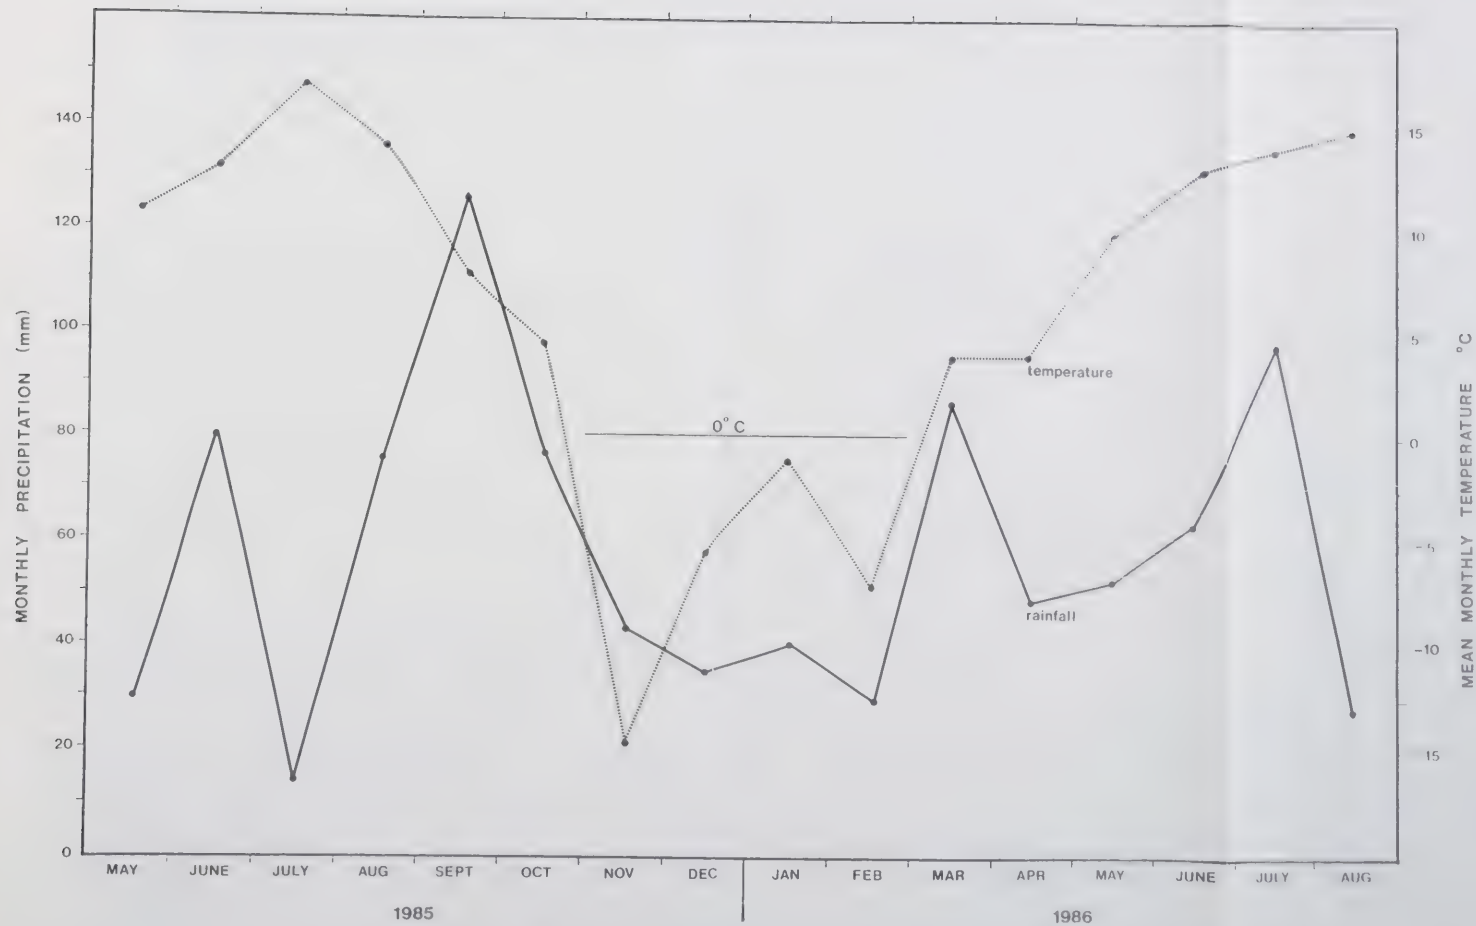
Figure 24. Monthly precipitation and mean monthly temperature data for the period of observation (May 1985 to August 1986).

Figures 12 and 13 illustrate the precipitation history at the McBride site in the form of total annual precipitation (including snowfall) from 1923 to 1986, and average monthly precipitation from 1923 to 1986 respectively. Figure 24 gives a more detailed record of monthly precipitation from May 1985 to August 1986 (roughly the period of piezometric observations).

Figure 24 illustrates a plot of the average monthly temperature over the period of piezometric record (May 1985 to August 1986).

1) A study of the total precipitation records illustrated in Figure 24 indicates peak precipitation periods in September-October, March, and June-July. Temperature data indicates that average daily temperatures fell below 0° C between November 4, 1985 and February 23, 1986. Therefore, groundwater level increases in September/October, March and June/July would be anticipated due to rainfall. It would also be expected that the period from November to March would be a period of static or declining phreatic levels, with a resurgence in March due to spring thaw. Therefore, the following cyclic groundwater level fluctuations may be predicted:

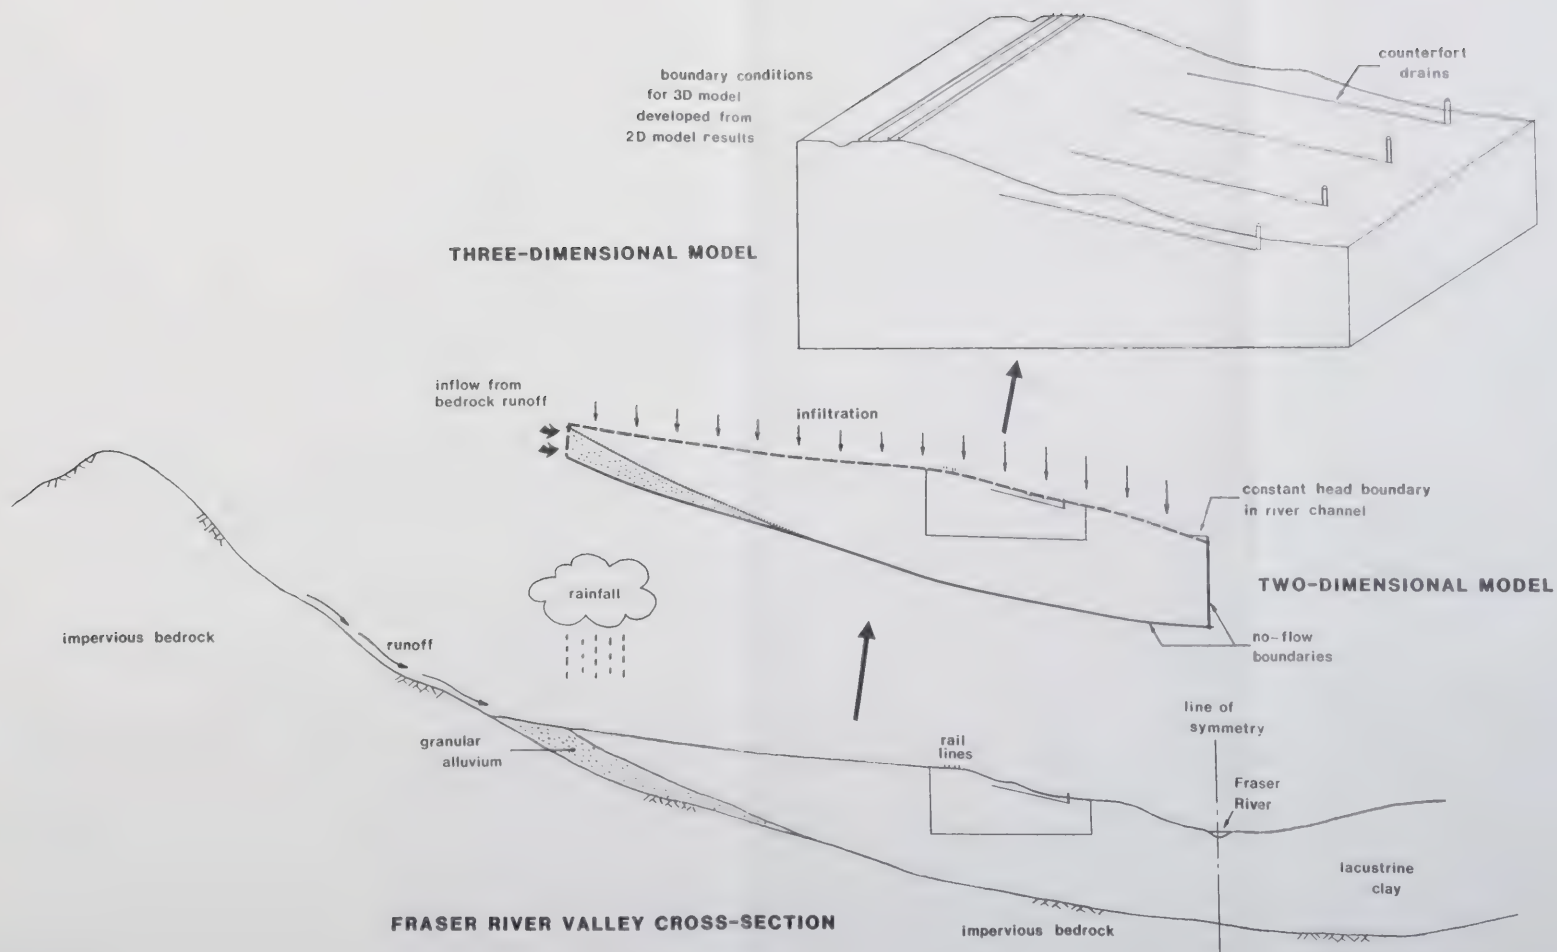
Figure 26. Schematic illustration of groundwater flow model slope geometry for use in numerical modelling

A useful starting point, prior to attempting the 3D modelling, would be to begin with a coarse-meshed, two-dimensional (2-D) model of the Fraser River valley as illustrated in Figure 26. This 2-D model could be used to explore the influence of varying boundary conditions and
